Report of Marine Survey

"Boat for Sale"

Auxiliary Sailing Catamaran

August 24, 2015

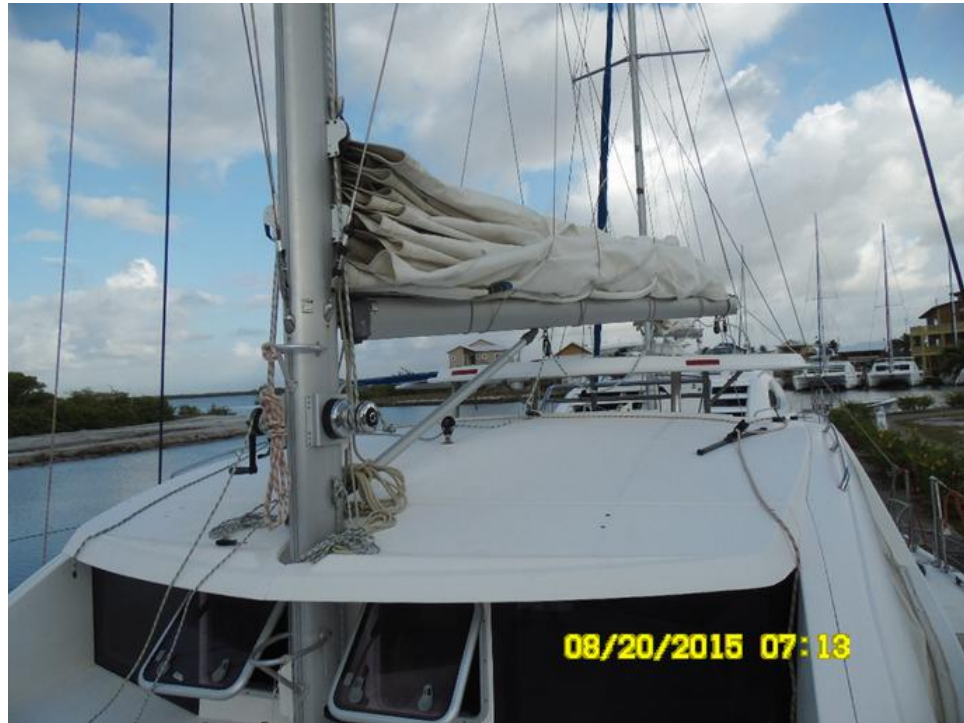
SAM_8977.JPG

Stack pack has been removed and not seen.	
FINDINGS	RECOMMENDATIONS
No main sail cover or stack pack to prevent sun damage to main sail (photo SAM_8977).	Reported to be removed for service and to be returned to vessel in near future.

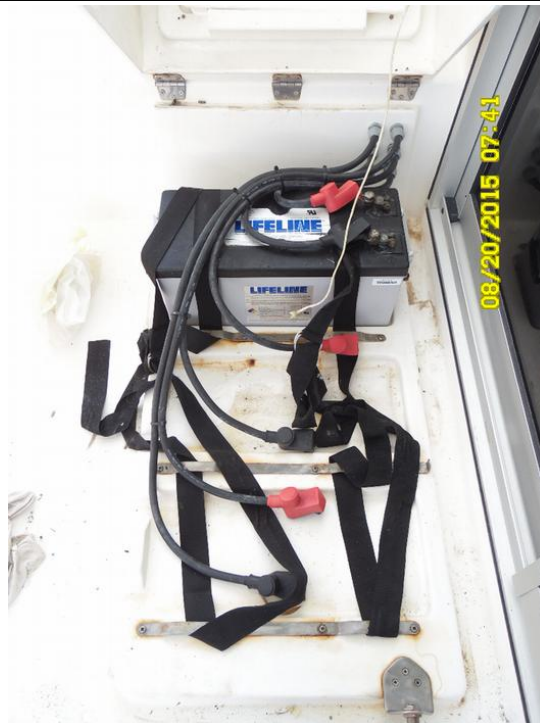
SAM_9056.JPG

One (1) Group 31 size lead acid battery located in each engine room seen properly secured in acid proof boxes. One (1) 8D side AGM battery located under cockpit seating area was seen properly secured. Batteries were tested with a Cen-Tech Digital Battery Analyzer as follows: Port starting battery: Rated Good at 100% (photo SAM_9031) Starboard starting battery: Rated OK at 70% (photo SAM_9046) Main house batteries: One (1) tested - Rated Good at 100%	
FINDINGS	RECOMMENDATIONS
Provision for three (3) 8D size batteries exists in the area for the house batteries however only one (1) battery was installed at time of this survey inspection (photo SAM_9056)	<i>Install additional house system batteries as required.</i>

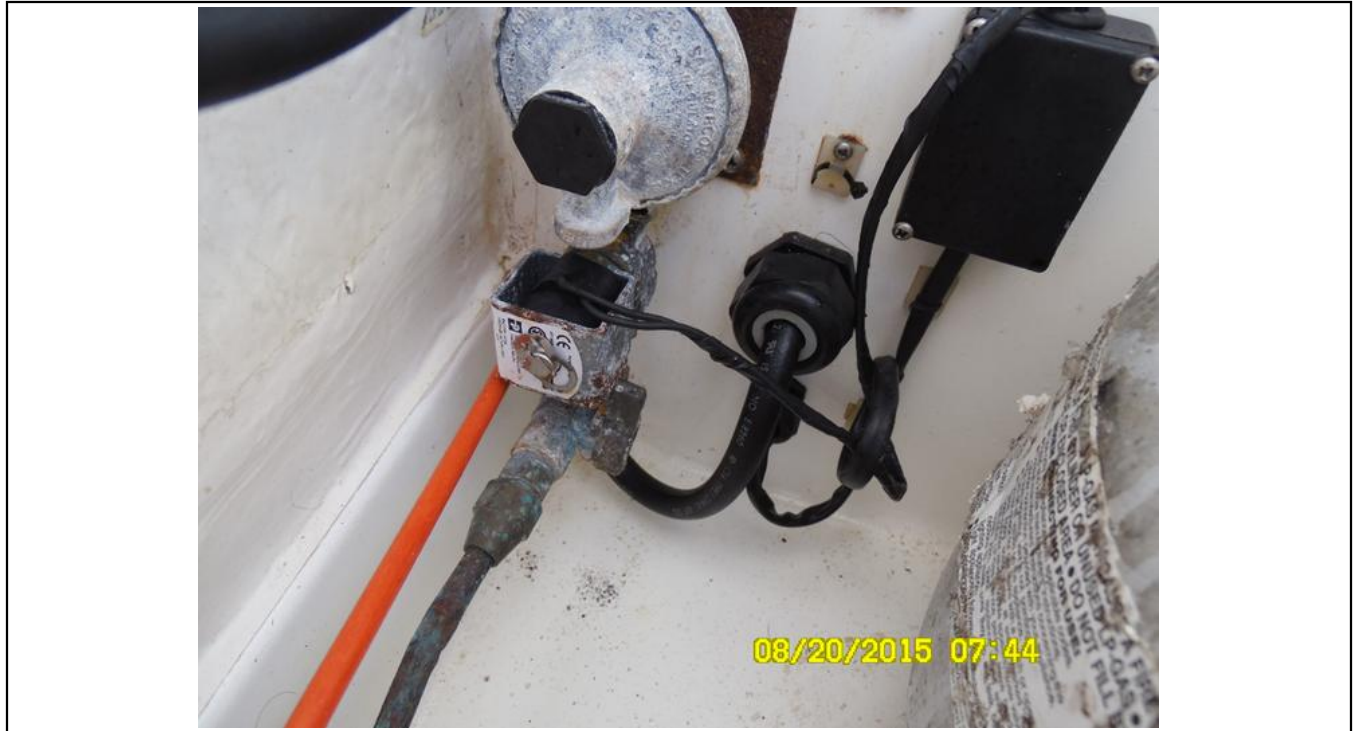
SAM_9063.JPG

All appear serviceable where sighted.	
FINDINGS	RECOMMENDATIONS
Some corrosion was seen on regulator and fittings (photo SAM_9063)	<i>Recommend cleaning fittings</i>

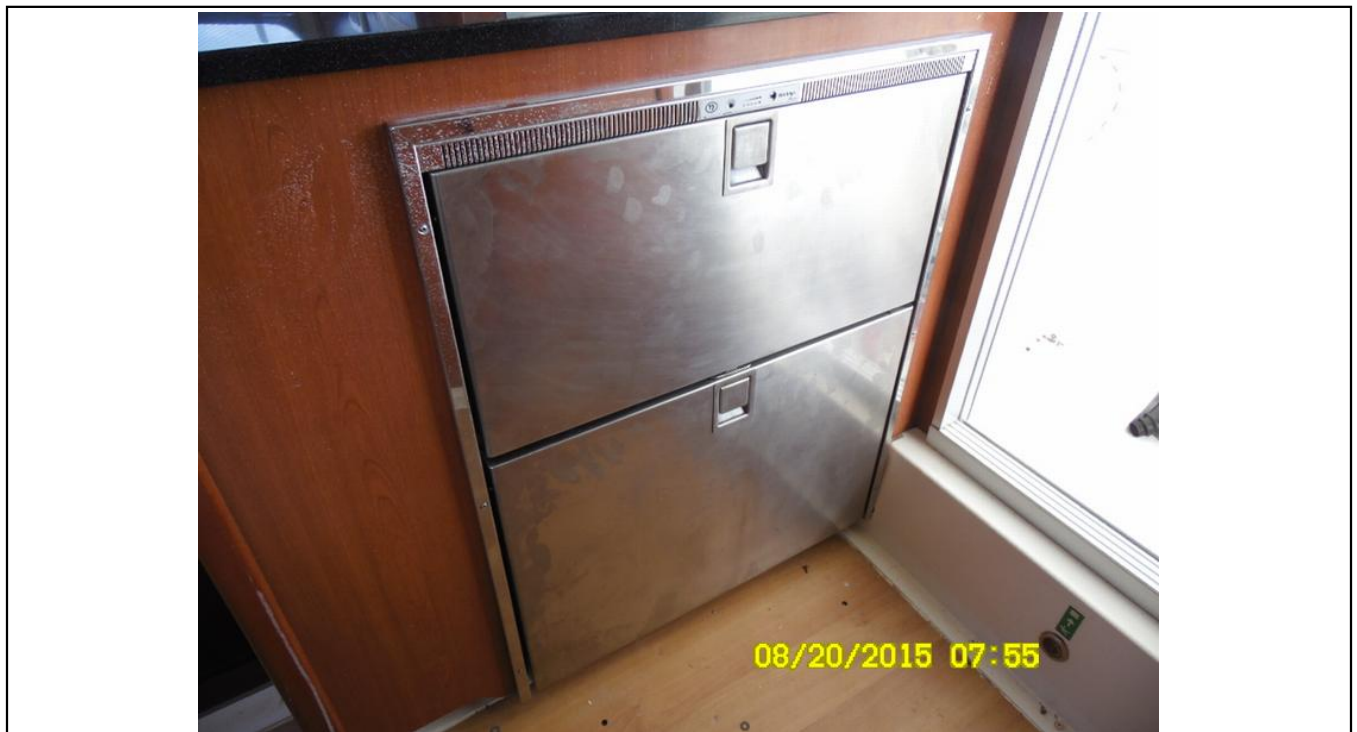
SAM_9086.JPG

Satin varnish finish seen in good condition.	
FINDINGS	RECOMMENDATIONS
Some minor finish wear was noted in high traffic areas. Note corner molding in bottom left of photo SAM_9086 and entry to bed in photo SAM_9110	All seen is expected as normal wear and tear.

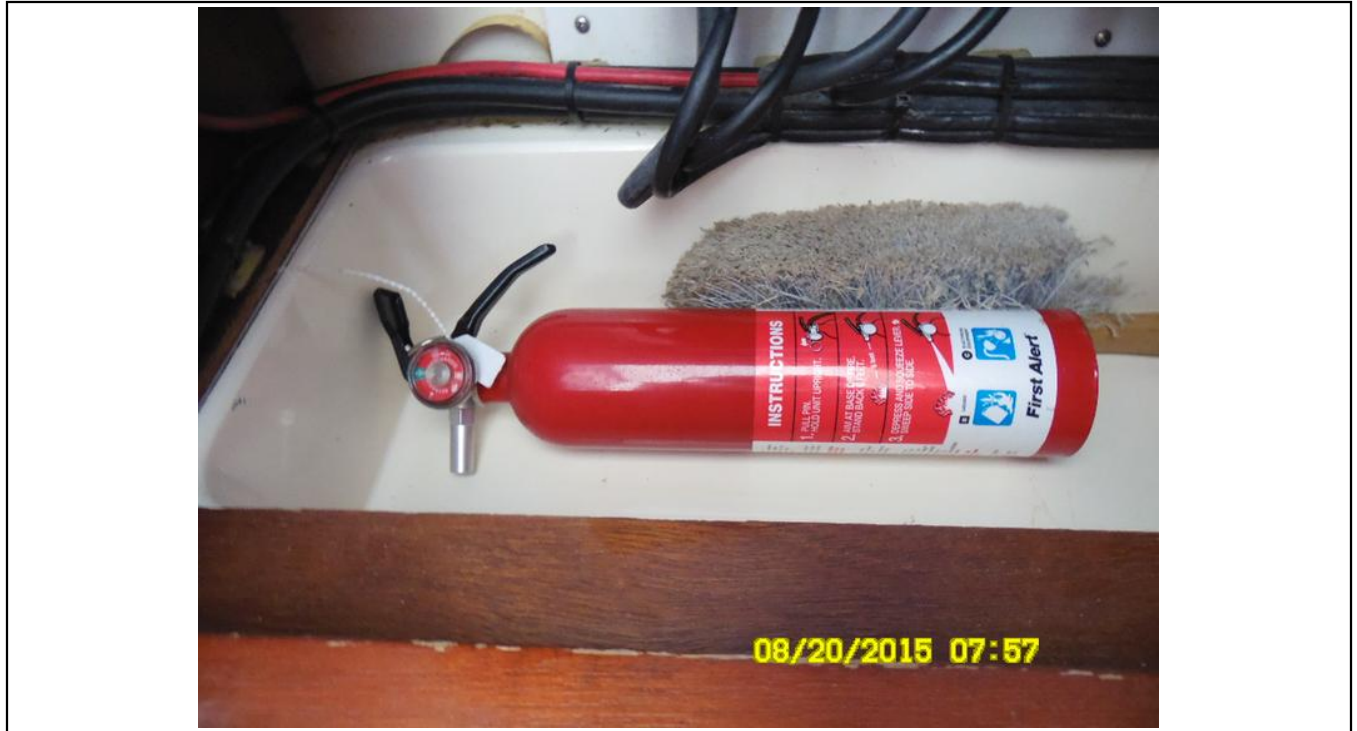
SAM_9097.JPG

Type BI (2lbs) dry chemical with gauges seen serviceable. One (1) located in port hull amidships One (1) Unmounted in galley locker under sink.	
FINDINGS	RECOMMENDATIONS
One (1) fire extinguisher was missing from area in starboard midships hull where a tag indicating that a fire extinguisher should be mounted. Fire extinguisher seen unmounted and lying in galley locker under sink (photo SAM_9097)	<i>Comply with ABYC and NFPA recommended standards for fire protection.</i>

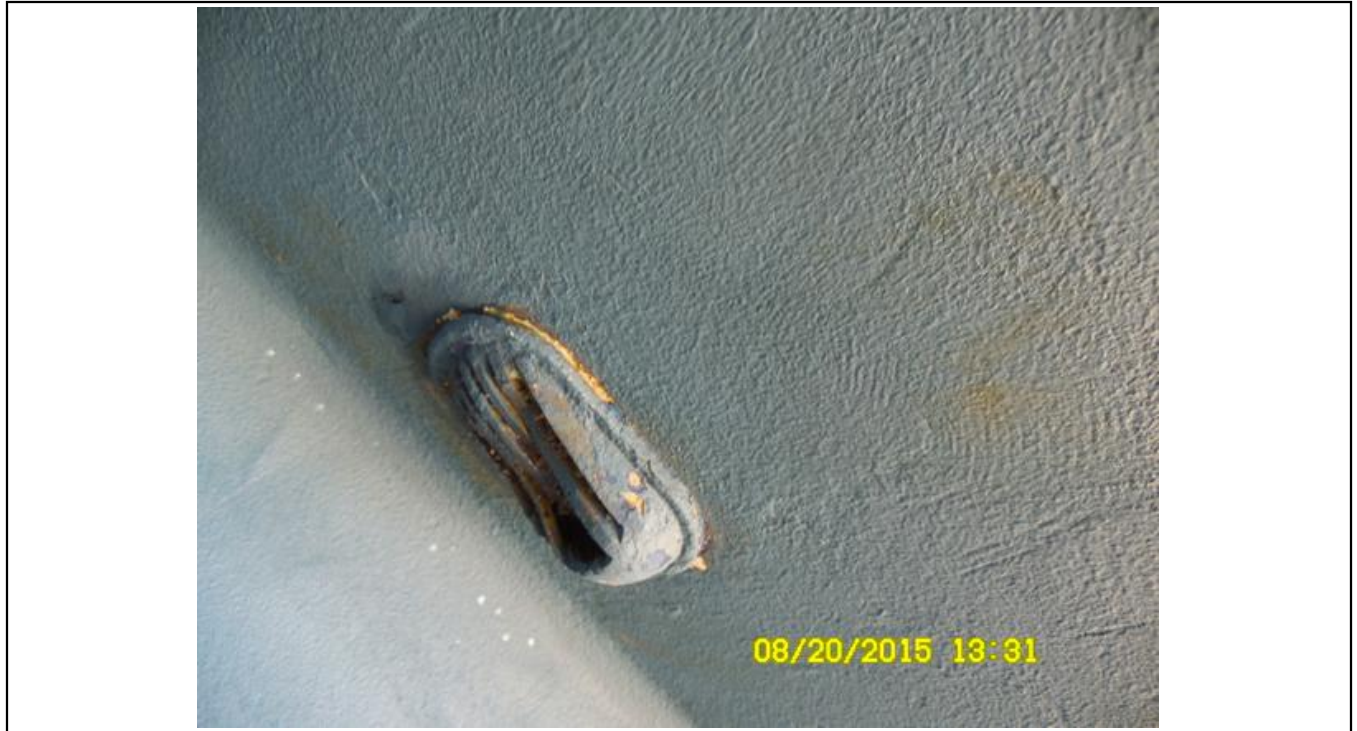
SAM_9216.JPG

All seen in good and serviceable condition except as noted.	
FINDINGS	RECOMMENDATIONS
Speed scoop through hull for starboard air conditioner seen slightly damaged with dents (photo SAM_9216)	Clean and straighten damaged speed scoop through hull.
